Your Inspection Report

great home
Ontario, ON

Monday, February 8, 2021

RE: Report No. 1227
great home
Ontario, ON

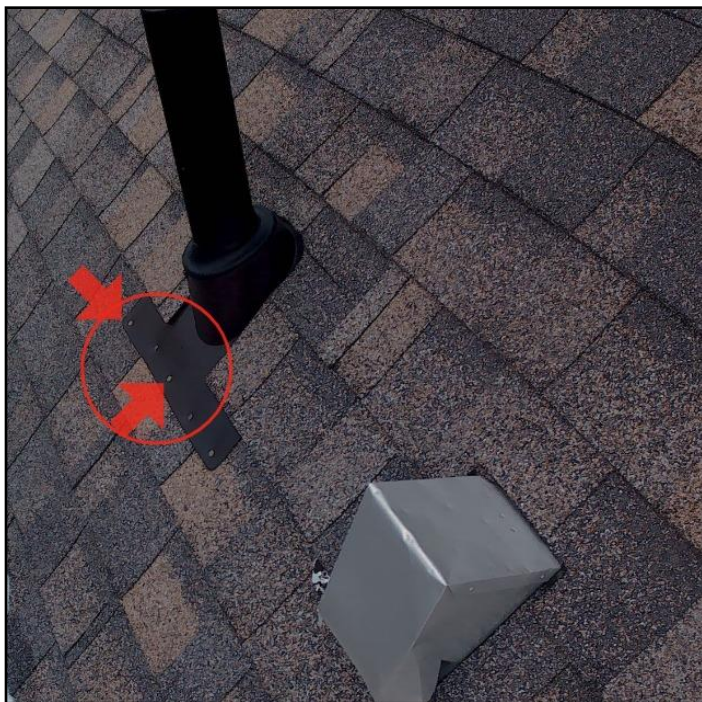
2. Condition: • Fasteners - exposed / missing

Implication(s): Chance of water damage to structure, finishes and contents

Location: Left Side Exterior Roof

1. Fasteners - exposed / missing

Task: Repair

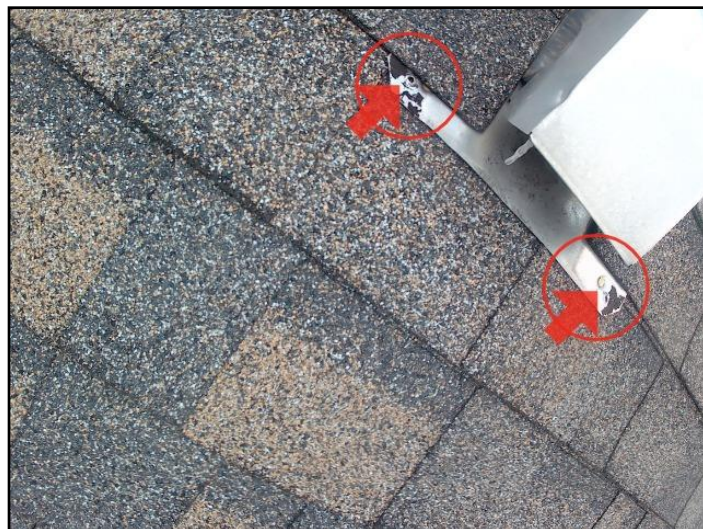
2. Fasteners - exposed / missing

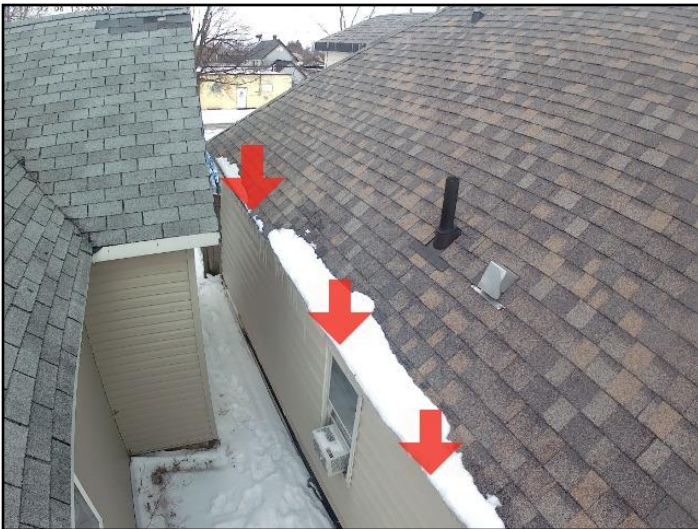
4. Condition: • Missing

Gutters/downspouts are recommended for all sides of the house to decrease the risk of water in an adverse storm from entering the basement,

3. Missing gutters/downspouts

Task: Repair

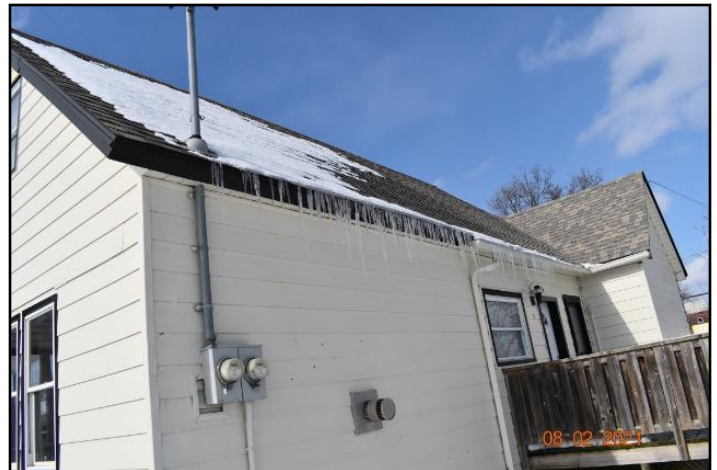
4. Missing gutters/downspouts

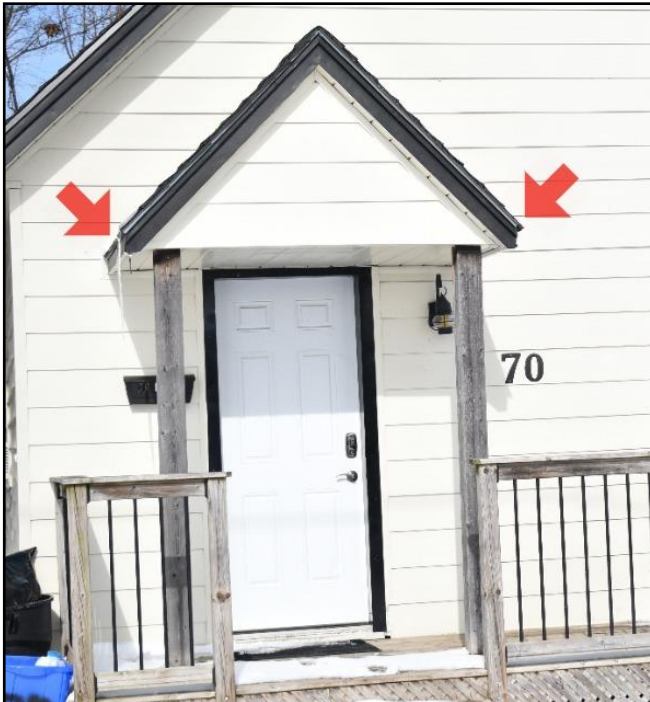
5. Missing gutters/downspouts

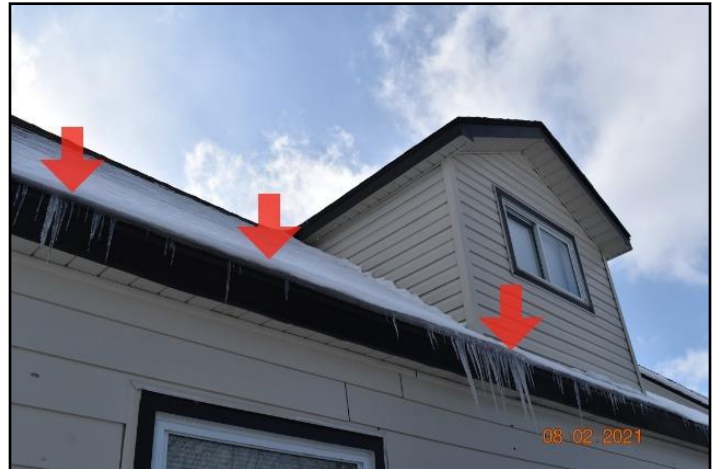
6. Missing

5. Condition: • Missing

It is a good practice to put dormer with gutters and downspouts to extend the lifespan of shingles

Location: Rear roof Dormer

Task: Repair

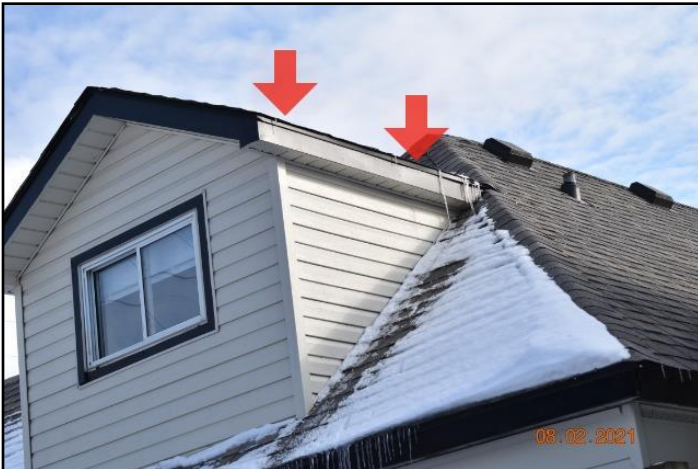
7. Missing gutter/downspouts

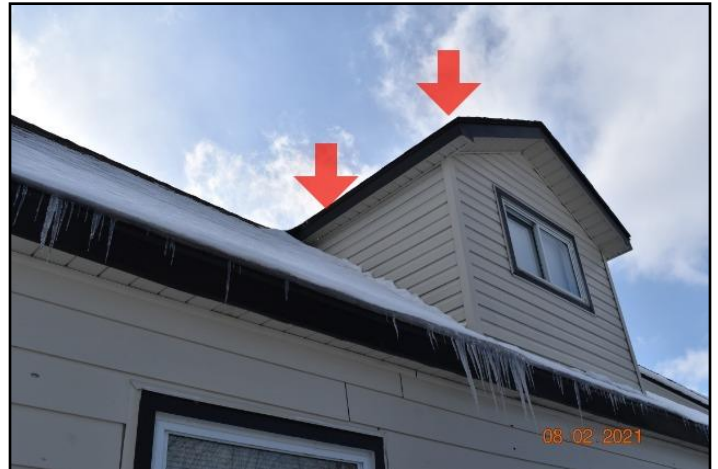
8. Missing

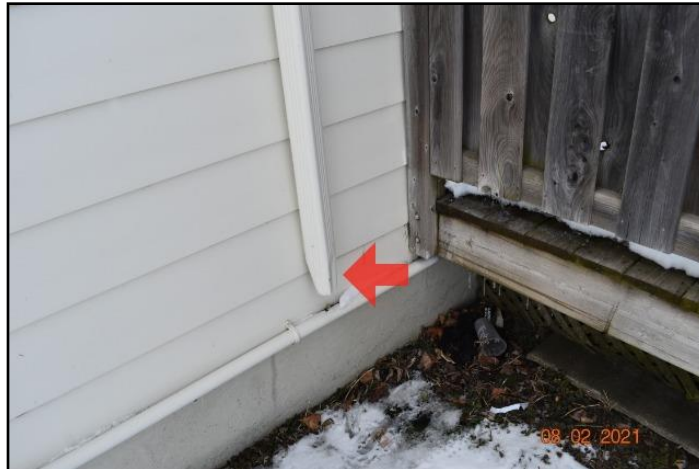
6. Condition: • Discharge too close to building

Implication(s): Chance of water damage to structure, finishes and contents

Location: Right Side Exterior

9. Discharge too close to building

Task: Repair

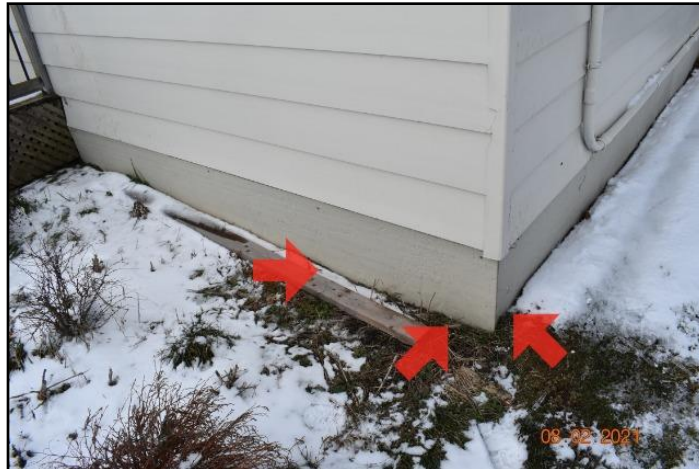
7. Condition: • Too close to grade

Siding materials are not meant to be in contact with the ground and will deteriorate if they are at or below grade. On virtually, every house, at least the top four or six inches of the foundation wall should be visible outside. We prefer to see at least six inches for wood siding. They are two reasons-the first is that siding may deteriorate from chronic dampness. The second is the risk of rot to the structure even brick homes have wood structural members inside.

Implication(s): Chance of water damage to structure, finishes and contents | Material deterioration | Rot | Insect damage

10. Too close to grade

Task: Repair

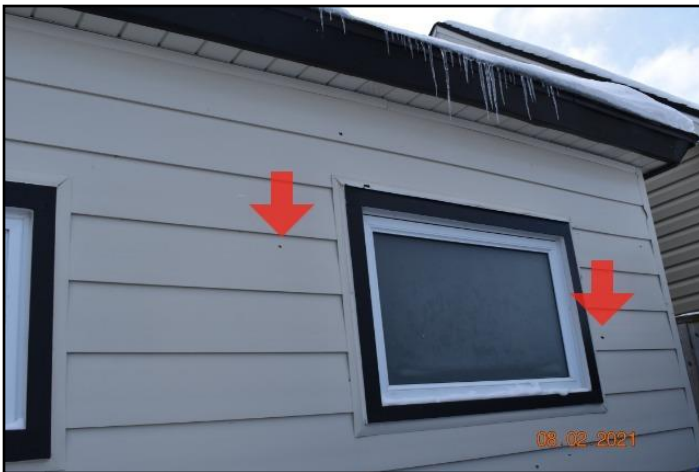
8. Condition: • Mechanical damage

Implication(s): Chance of water damage to structure, finishes and contents

Location: Rear Right Side Exterior

11. Mechanical Damage

Task: Repair or replace

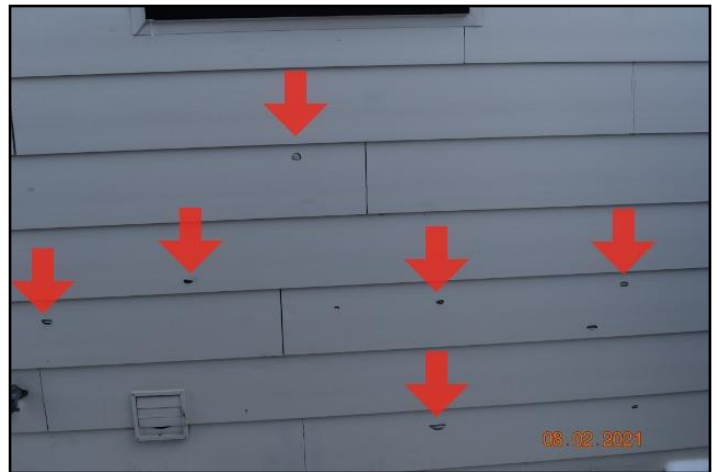
12. Mechanical Damage

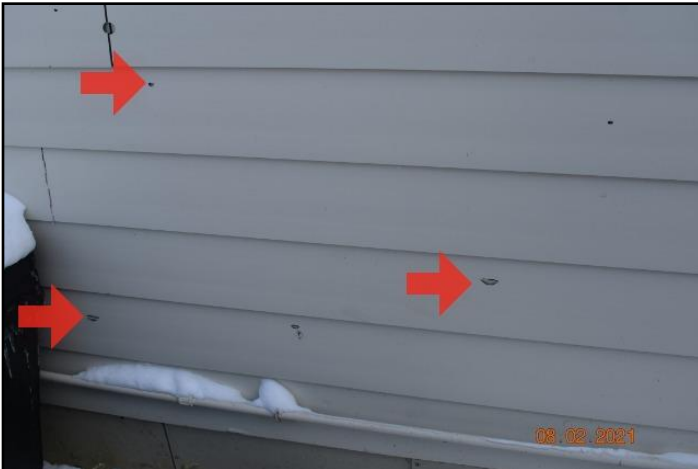
13. Mechanical damage

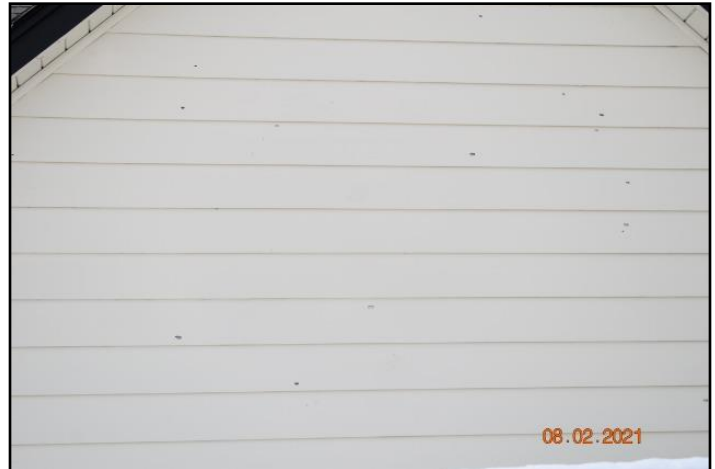
14. Mechanical damage

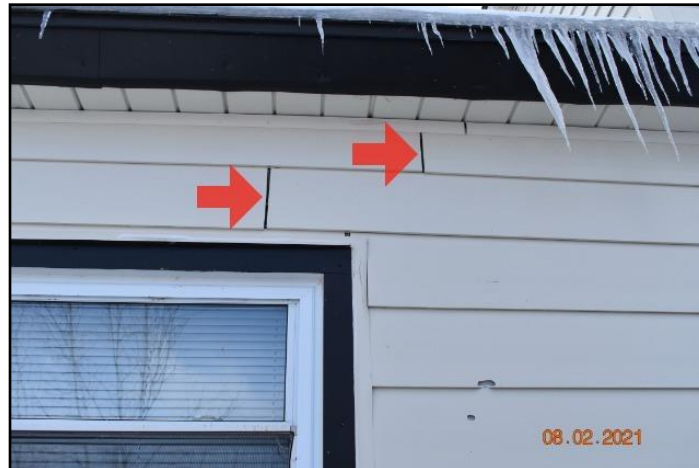
9. Condition: • Loose or missing pieces

Implication(s): Chance of water damage to structure, finishes and contents

Location: Rear Exterior

15. Loose pieces

Task: Repair

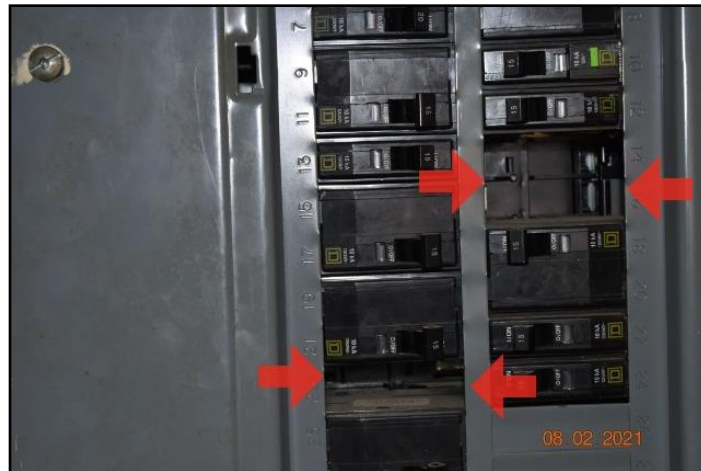
12. Condition: • Openings in panel unprotected openings should be closed.

Implication(s): Electric shock | Fire hazard

Location: First Floor(Rear Unit)

16. Openings in panel(Rear Unit)

Task: Repair

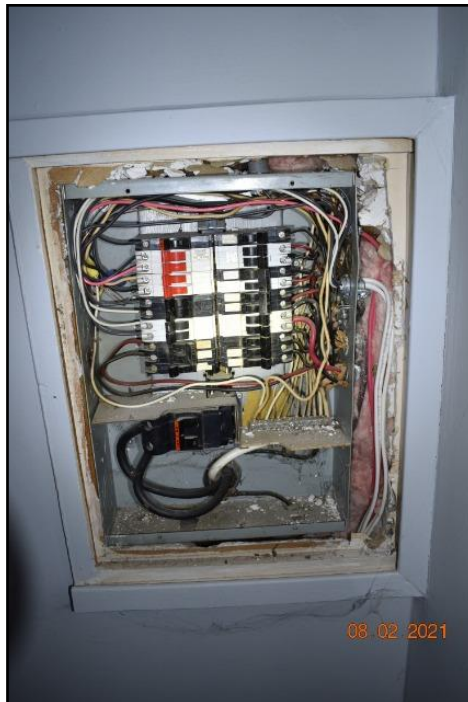
13. **Condition:** • Circuits not labeled

Implication(s): Nuisance

Location: Front Unit First Floor

17. Circuits not labeled (Front Unit)

Task: Repair

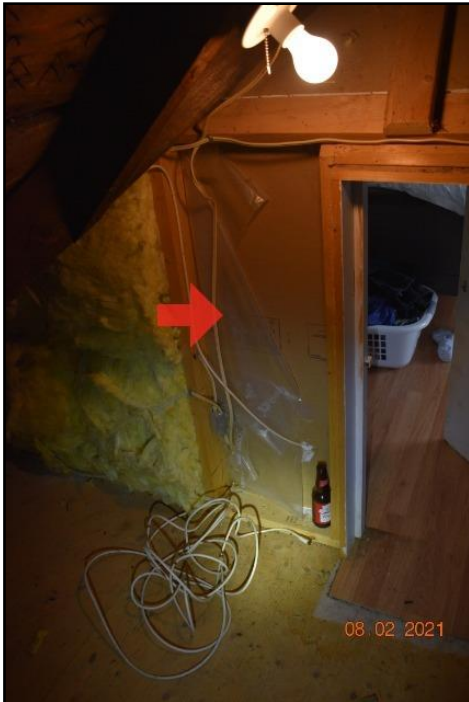
16. Condition: • Gaps or voids

Implication(s): Increased heating and cooling costs | Reduced comfort

Location: Attic

18. Gaps or voids

Task: Repair

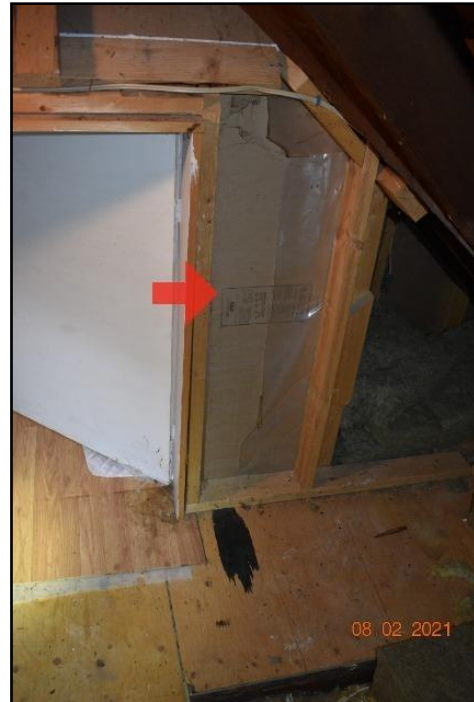
19. Gaps or voids

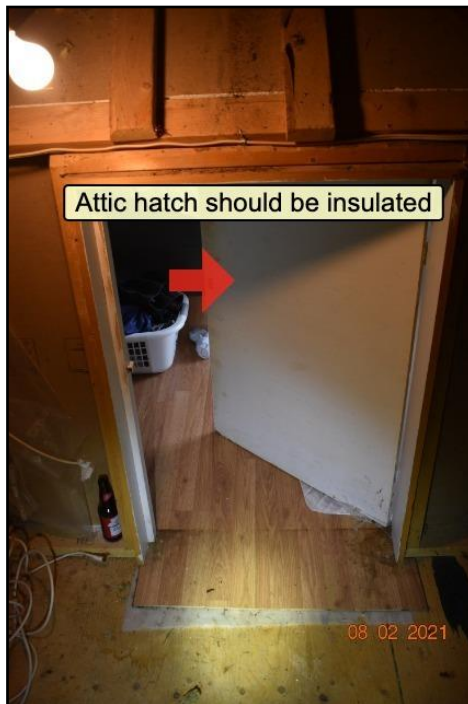
20. Gaps or voids

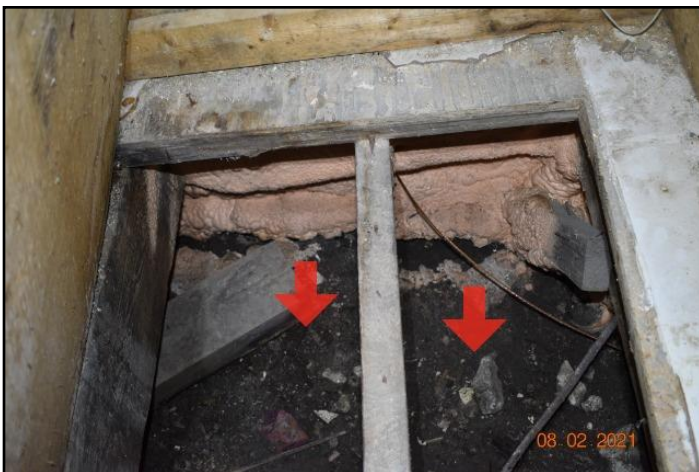
17. Condition: • No vapor barrier

If the floor is earth and not covered with concrete or some other impervious material, a vapor/moisture barrier layer, such as at least a polyethylene sheet, is recommended to cover the earth, in order to minimize the chance of moisture damage to structural members due to the elevated moisture level in the air in crawlspace.

Implication(s): Chance of condensation damage to finishes and/or structure

21. No vapor barrier

Task: Provide

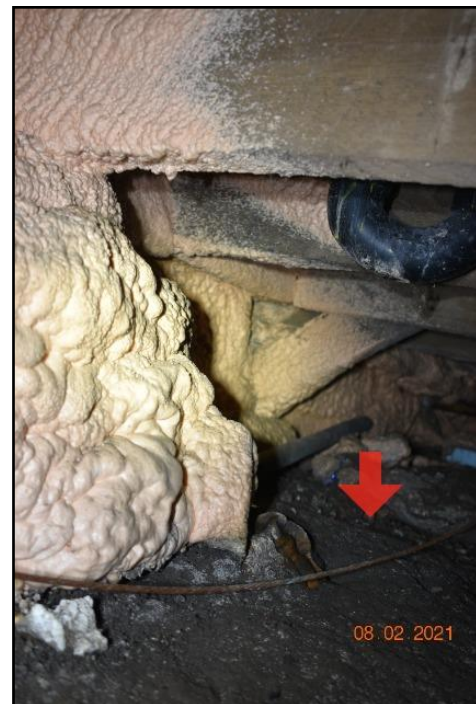
22. No vapor barrier

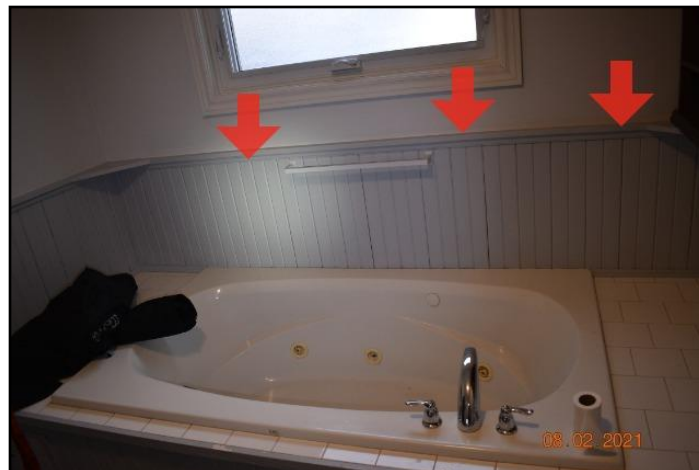
18. Condition: • Not smooth, impervious or water resistant

Implication(s): Hygiene issue

Location: Rear Unit First Floor Bathroom

23. *Not smooth, impervious or water resistant*

Task: Repair

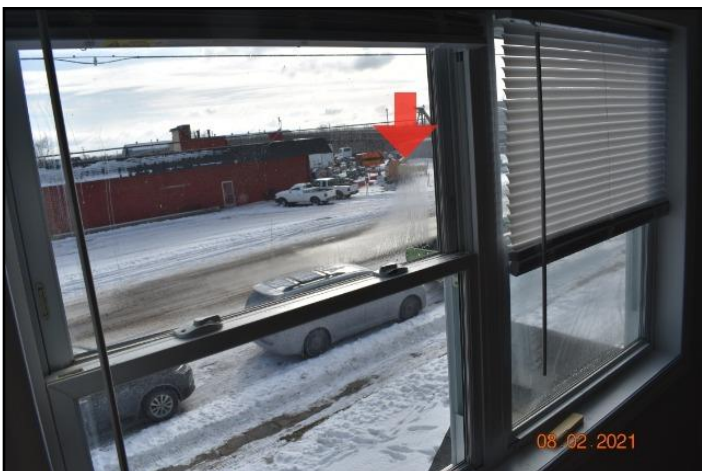
21. Condition: • Lost seal on double or triple glazing

Lost seals are not particularly serious from an energy efficiency standpoint. The window will still perform reasonably well. However, visibility is often reduced and the glass may look cloudy, even if there is no condensation present at the moment. Once the seal is gone, condensation will appear and disappear between the panes. This, however, leaves the interior surfaces of the glazing dirty and the cloudy appearance develops.. The average cost for repair/replace will be \$180+/each sash.

Implication(s): Shortened life expectancy of material

24. Lost seal on double or triple glazing

Task: Repair

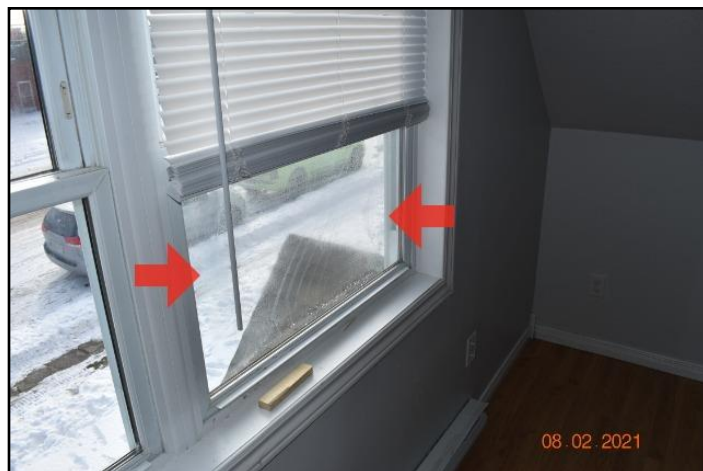
25. Lost seal on double or triple glazing

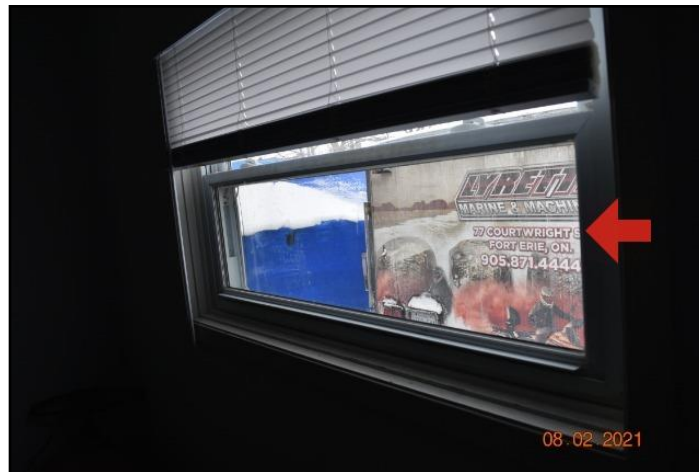
22. Condition: • Won't stay open

Implication(s): Nuisance | Glass breaking | Physical injury

Location: First Floor bedroom(rear unit)

26. *Won't stay open*

Task: Repair

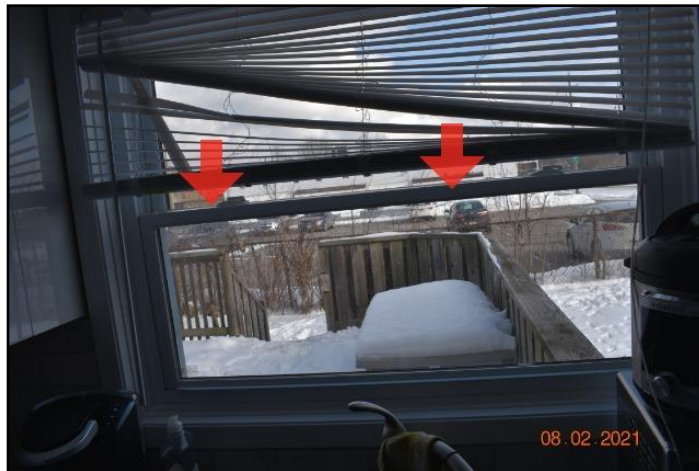
23. Condition: • Won't stay open

Implication(s): Nuisance | Glass breaking | Physical injury

Location: First Floor Kitchen(Front Unit)

27. Won't stay open

Task: Repair

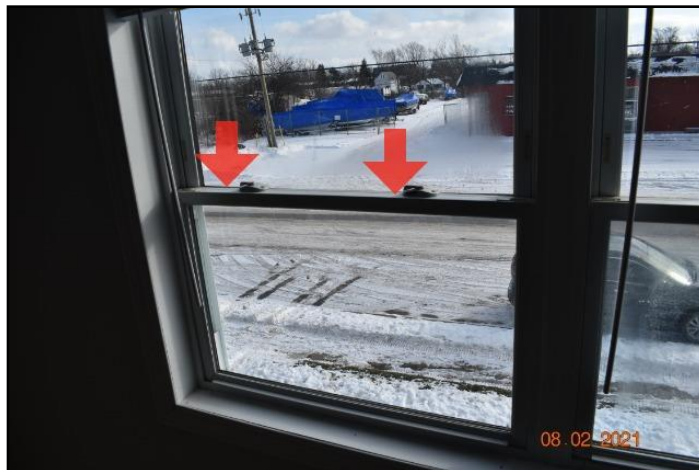
24. Condition: • Won't stay open

Implication(s): Nuisance | Glass breaking | Physical injury

Location: Front Unit Second Floor Bedroom

28. Won't stay open

Task: Repair

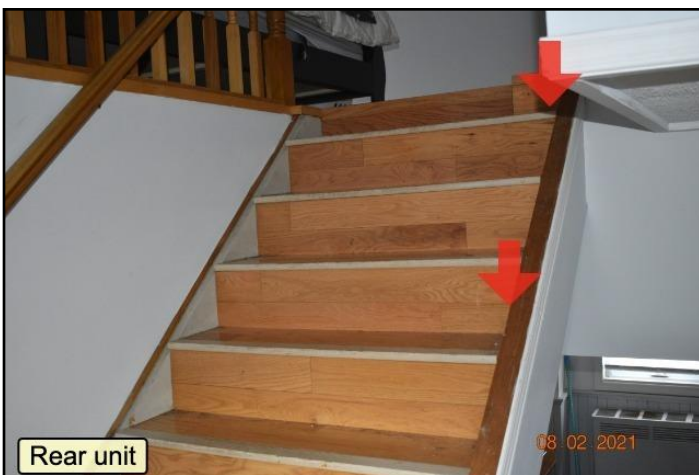
25. Condition: • Missing

Implication(s): Fall hazard

Location: Second Floor

29. Missing guardrail

Task: Provide

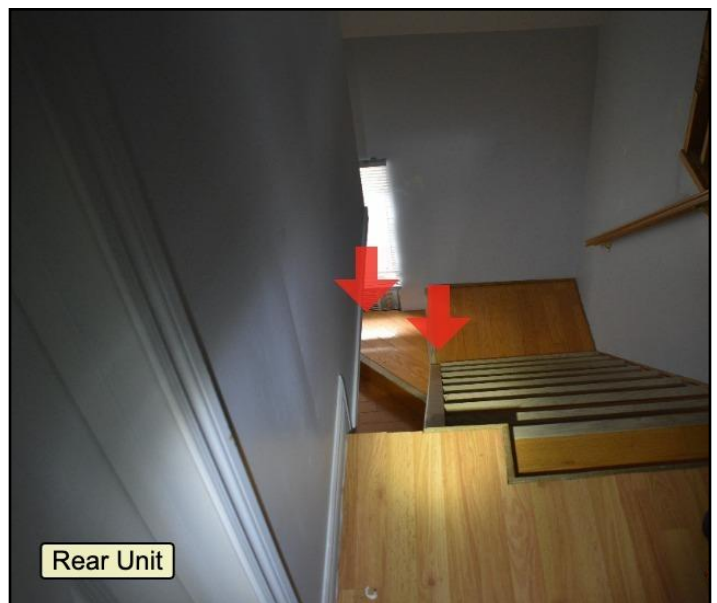
30. Missing guardrail

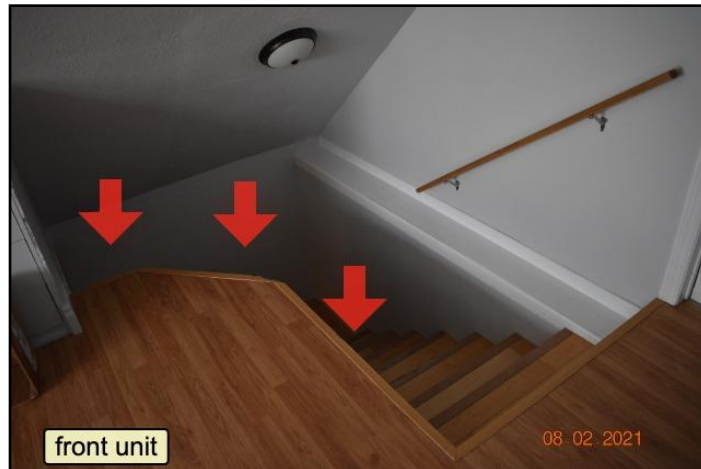
31. Missing guardrail

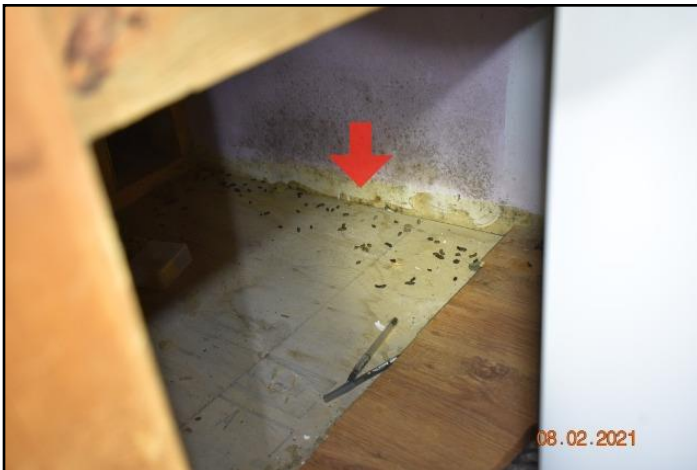
26. Condition: • Mouse/animal droppings

The Seller should be asked about the mouse droppings and the rodent traps noted in the rear unit and attic

32. Mouse/animal droppings

Task: Request disclosure

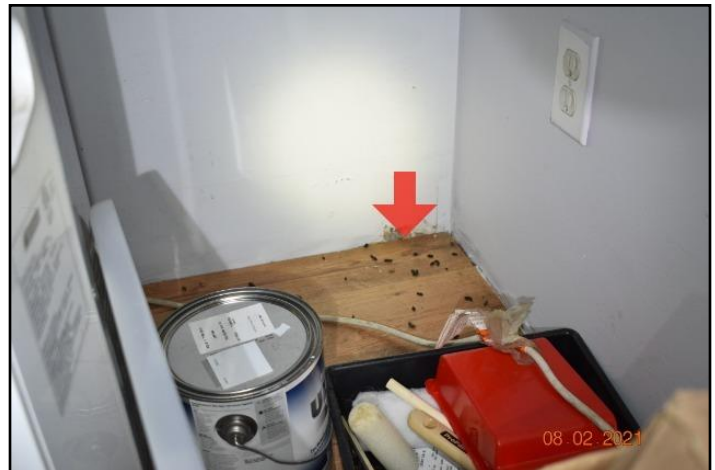
33. Mouse/animal droppings
